# Intel® 5000 Series Chipset Memory Controller Hub (MCH)

Specification Update

*May 2008*

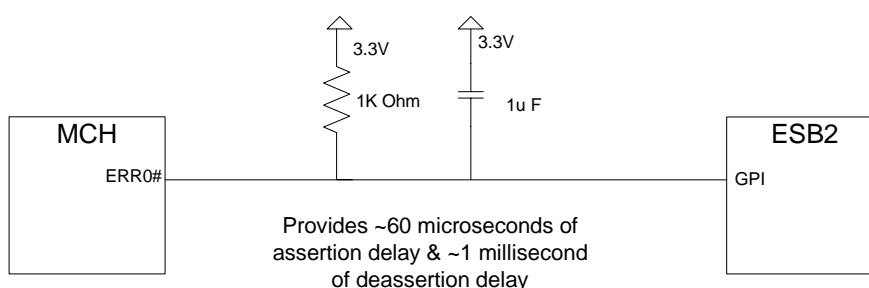
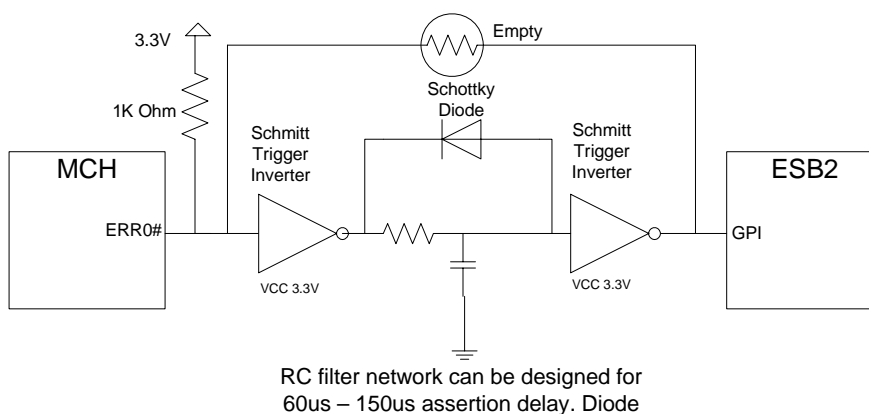
**Problem:** Any condition routed to MCH ERR[2:0]# output pins for SMI# escalation that would result in data poisoning on FSB will result in a CPU IERR# assertion due to race condition. The race condition exists between poisoned data presented to the FSB by the MCH and the uncorrectable error escalated to SMI# via ERR[2:0]# pins. If the CPU observes an SMI# assertion before the poisoned data is presented to the FSB, the CPU asserts MCERR# followed by IERR#. The CPU expects the SMI# assertion to occur at least 10 BCLKs after the associated MCERR# assertion. Conditions that result in data

**Implication:** CPU may assert IERR# and cause a system hang before the error may be logged in SMM.

**Workaround:** The following workarounds have been identified:

1. Log errors upon reboot
  - System components (MCH, CPU, Southbridge) preserve errors across warm resets via sticky error registers
  - Requires a mechanism to reset system upon IERR# (server management controller, depress system reset button, and so forth)
2. Delay SMI# assertion by inserting a 60µs-150µs delay on the ERR0# pin
  - Two recommended circuit solutions (other solutions may be possible):

- Route errors that result in FSB data poisoning to the ERR0# pin (IO4, M2, M4-13, M15)

3. Disable FSB data parity checking on CPU
  - Prevents CPU from asserting MCERR# on poisoned data
